**MERRIMACK RIVER BASIN
EPSOM, NEW HAMPSHIRE**

**NORTHWOOD LAKE DAM
NH 00285**

**PHASE I INSPECTION REPORT
NATIONAL DAM INSPECTION PROGRAM**

OCTOBER 1978

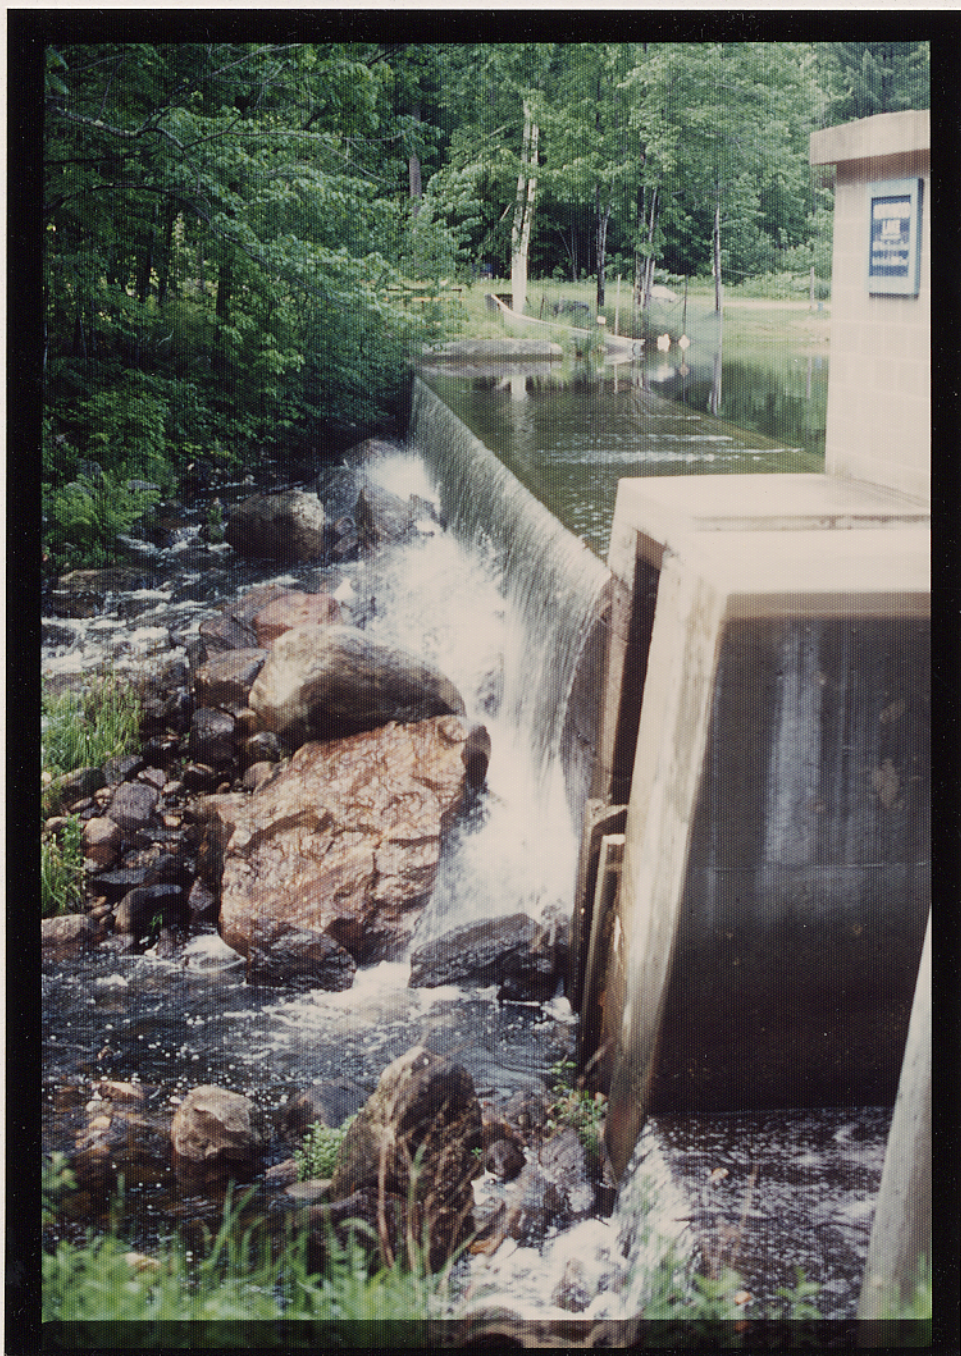
NORTHWOOD LAKE DAM

General view of the dam from downstream looking toward the right abutment. The stop plank section and the low level outlet are in the foreground, the spillway section is in the background.

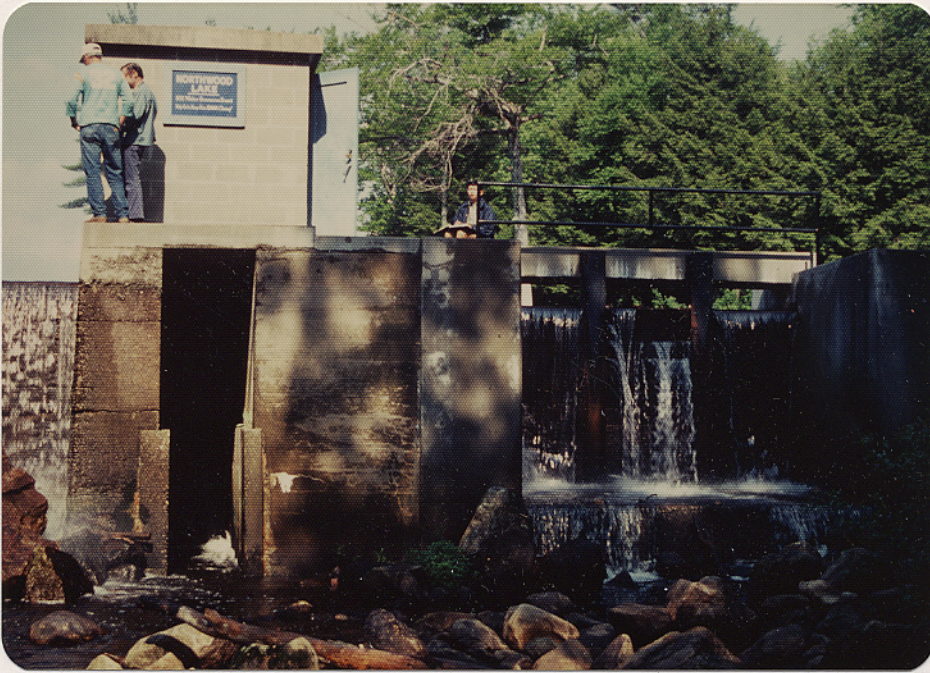
Photo 1 - View of the left abutment from downstream. The spillway is on the left of the picture, the low level outlet is in the center with the gate house over it, and the new stop plank section is on the right.

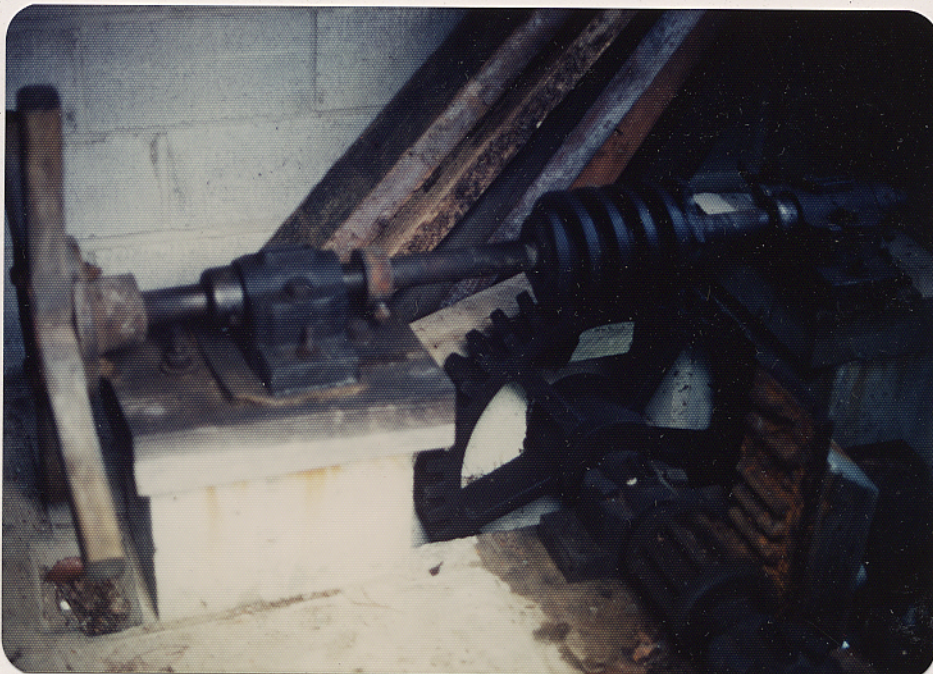
The gate is manually operated by a combination of worm gearing and spur gearing. The gate stem is a 4 in. by 8 in. timber equipped with a cast iron rack spiked to the stem. The stem timber appeared to be in very good condition; however, the rack showed heavy corrosion, and the top two teeth had broken off. The operating mechanism is not securely anchored to the concrete structure of the dam. The existing arrangement employs concrete and timber blocks which hold the operating mechanism approximately one foot above the floor of the gate house. This block arrangement does not have the strength to withstand the horizontal forces developed by the worm gear, and at present the blocks deflect slightly when force is applied to the handwheels.

The operating mechanism employs a back up roller which holds the gate stem and rack against the pinion gear and prevents the timber stem from deflecting. Originally this roller was held in place by two cast iron bearing caps bolted to the mechanism frame. Apparently, these iron bearing caps have either broken or become excessively worn, because at the time of this inspection the back up roller shaft was held in place by wooden blocks bolted to the frame. If either of these wooden bearing caps were to fail, the gate would be inoperable until a replacement is fabricated.

In general, because of the many minor deficiencies in the operating mechanism, this gate is considered to lack operational reliability.

Photo 2 - Interior view of the gate house showing the gate hoist for the low level outlet. The gate hoist is inadequately anchored to the floor.

The low level outlet hoist is improperly attached to its base and should be reattached. Other recommended repairs to the hoist mechanism are described in Section 7.3.

For this reason, it is recommended that a new hoist pad be poured and properly anchored to the dam structure.

(5) Securely fasten the low level outlet gate hoist to the floor of the gate operating house, so that it remains rigid during operation. Repair missing teeth on the gate hoist rack. Replace wooden hoist stem backing roller shaft bearing caps with cast iron ones of suitable design.

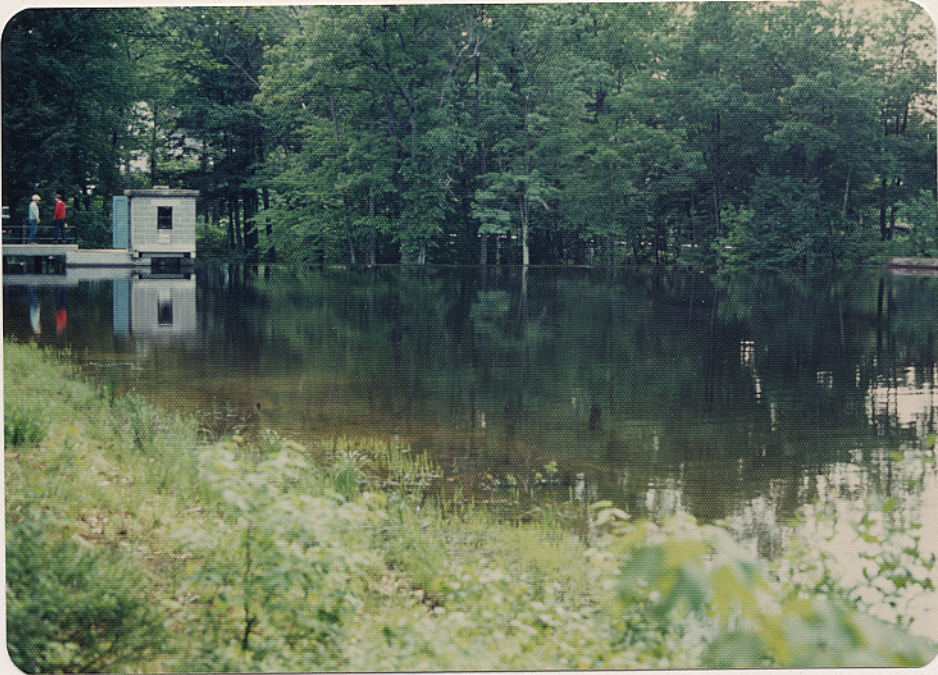
Photo 3 - View of the dam from the upstream side.

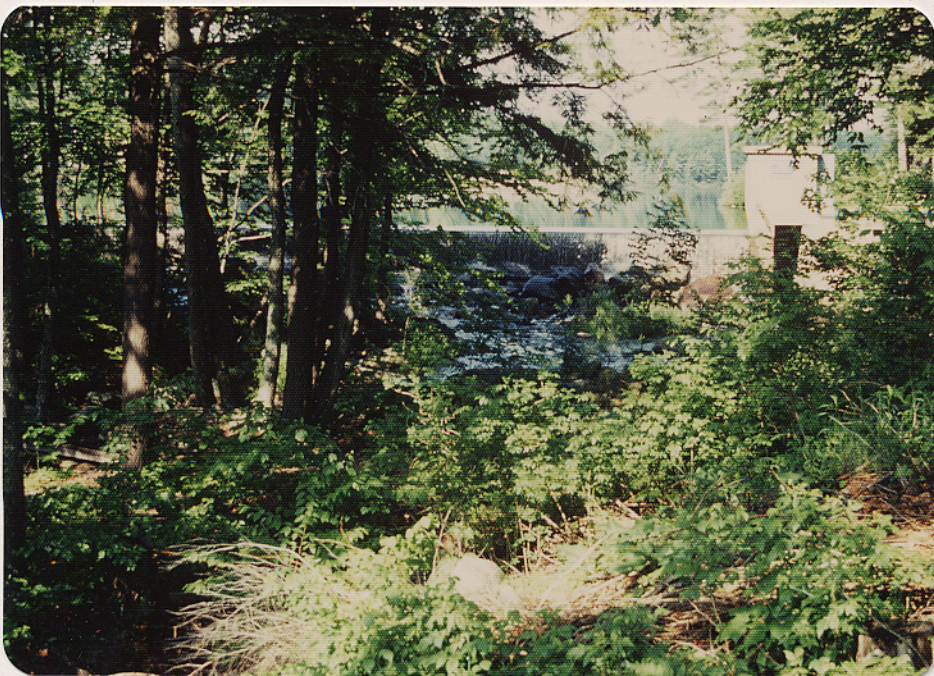
Photo 4 - View of the dam from the roadway crossing downstream of it. Note that the area downstream of the spillway on the left side of the picture is partly blocked by tree growth.

Recommended maintenance actions to be completed within 12 months relate to the selective clearing of trees in the area downstream of the spillway and along the banks of the river reach between the dam axis and the roadway bridge downstream of the dam.

and cause damage to or plugging of the roadway bridge immediately downstream of dam. Selectively remove trees along the reach of Little Suncook River channel that pose a similar potential risk to the bridge.

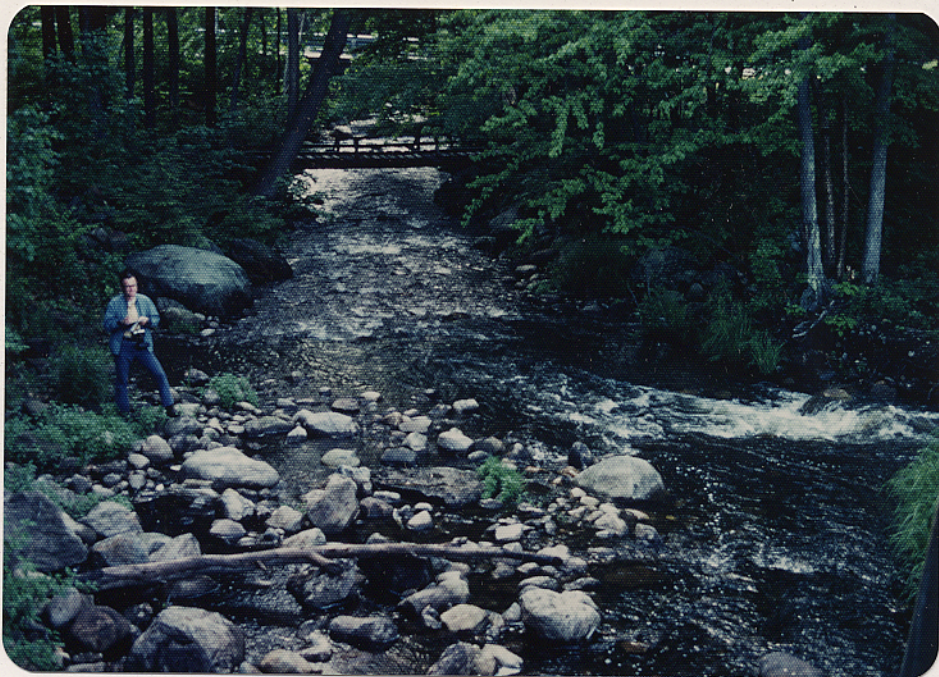
The immediate downstream channel of the Little Suncook River is well defined having a width of approximately 15 feet and rocky or riprapped side slopes of 1 on 4 horizontal. Immediately downstream of the dam, the transition zone area between the 110-foot wide spillway and the 15-foot wide river channel is overgrown with trees, some of which form an island. The stream reach between the dam axis and the nearest downstream road crossing also has trees growing close to the normal channel of river. All of these trees are considered a potential hazard at high spillway or outlet discharges, in that they could be uprooted and plug to the downstream bridge opening, thus creating undesirable high tailwater levels at the dam.

Photo 5 - View of the downstream channel of Little Suncook River taken from the dam.

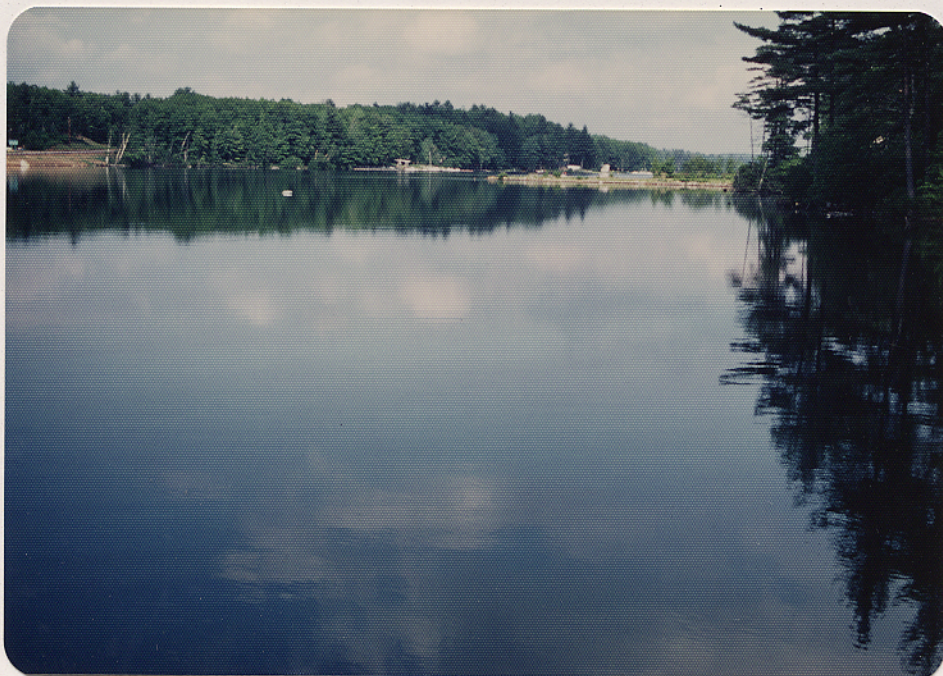
Photo 6 -View of the rim of Northwood Lake taken from the dam axis.
